# HAMDAN SUBSTATION BASRAH, IRAQ

SIGIR PA-05-006 MARCH 10, 2006

#### Hamdan Substation in Basrah, Iraq

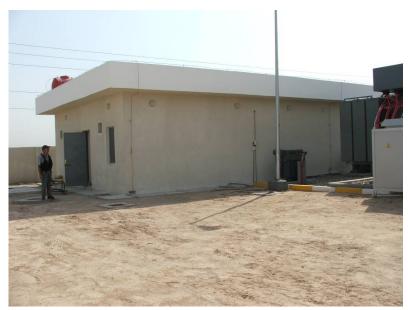
The contract and approved design included new construction of a substation building to house the 33 kilowatt (kW) switchgear, 11 kW switchgear, and associated monitoring and control equipment. Requirements included office space, bathroom facility, HVAC systems, fire alarm, internal lighting, and septic system. The 90% design drawings required a 22.280 meter (m) (73.1 feet (ft)) by 8.720 m (28.6 ft) building with a reinforced concrete slab foundation, below grade electrical cable trays, exterior block walls with exterior stucco and interior gypsum, and a reinforced concrete flat roof. Site photo 1 shows the exterior view of the substation building. The on-site assessment verified the construction of the facility was complete. In addition, the construction appeared to be consistent with the contract and design requirements.

Site Photo 1: Substation building exterior view

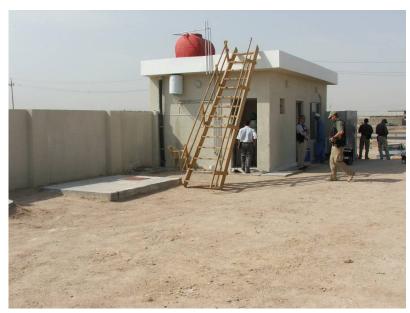
Site photo 2 shows the exterior fence, guard house (center of photo) and entry/exit gate (right of guard house). The on-site assessment verified the construction of guard house, exterior fence, and exterior lighting was completed and the construction appeared to be consistent with the contract and design requirements.

Site Photo 2: Exterior fence, guard house, and gate

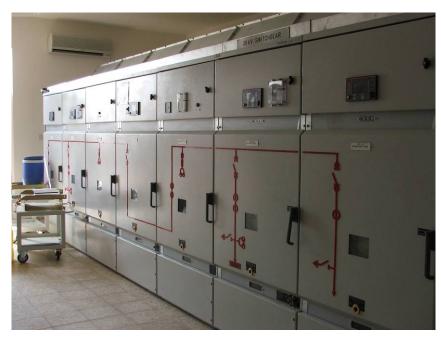
The on-site assessment verified the installation of the seven bay 33 kV switchgear. The associated factory nameplate lists the company as ABB, Board Type of UNIGEAR /82, rated voltage at 50 Hz and 36 kV, rated Busbar current as 1250 kA, short time current of 25 kA x 3 seconds. The units are listed as to standard IEC 82271-200. The serial number of this unit is 1VC1-8604001045-40000/2005. The equipment and installation appeared to be consistent with the contract, design, and specifications. Site photo 3 shows the 33 kV switchgear located inside the substation building.

Site Photo 3: 33 kV Switchgear

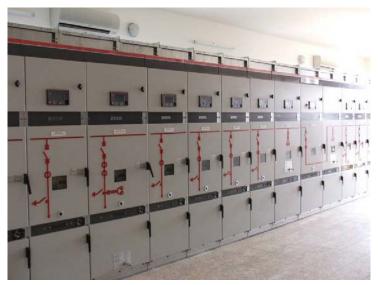
The 11 kV switchgear equipment and installation appeared to be consistent with the contract, design, and specifications. Site photo 4 shows the 11 kV switchgear located inside the substation building.

Site Photo 4: 11 kV switchgear

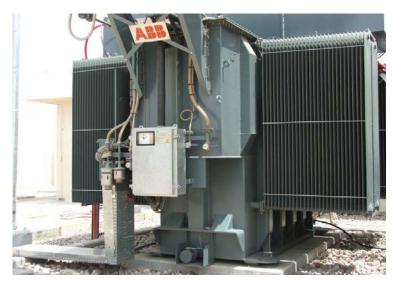
The equipment and installation appeared to be consistent with the contract, design, and specifications. Site photo 5 shows one of the two 33kV to 11 kV transformers.

Site Photo 5: 33 to 11 kV transformer

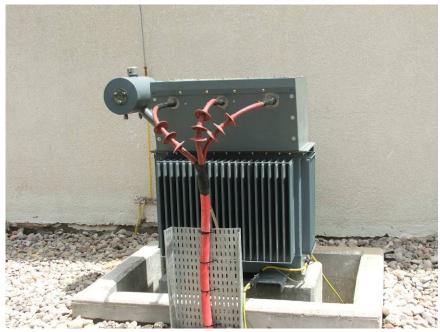
Site photo 6 shows the two installed 11 kV to 0.4 kV auxiliary transformers. The equipment and installation appeared to be consistent with the contract, design, and specifications.

Site Photo 6: 11 to 0.4 kV auxiliary transformers

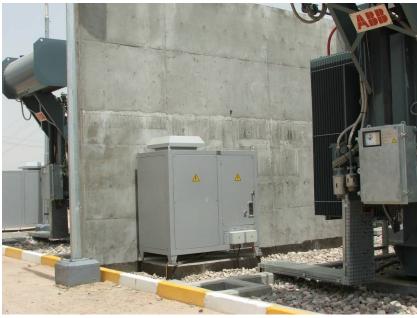
Site photo 7 shows one of the two installed neutral grounding units. The equipment and installation appeared to be consistent with the contract, design, and specifications.

Site Photo 7: Grounding system
